Post-Fire Metallic Degradation Following Lithium-Ion Battery Thermal Runaway: Observational Evidence from Field Investigation and Destructive Testing

Randy Narine¹ & Matthew D. Adams²

Preprint Notice

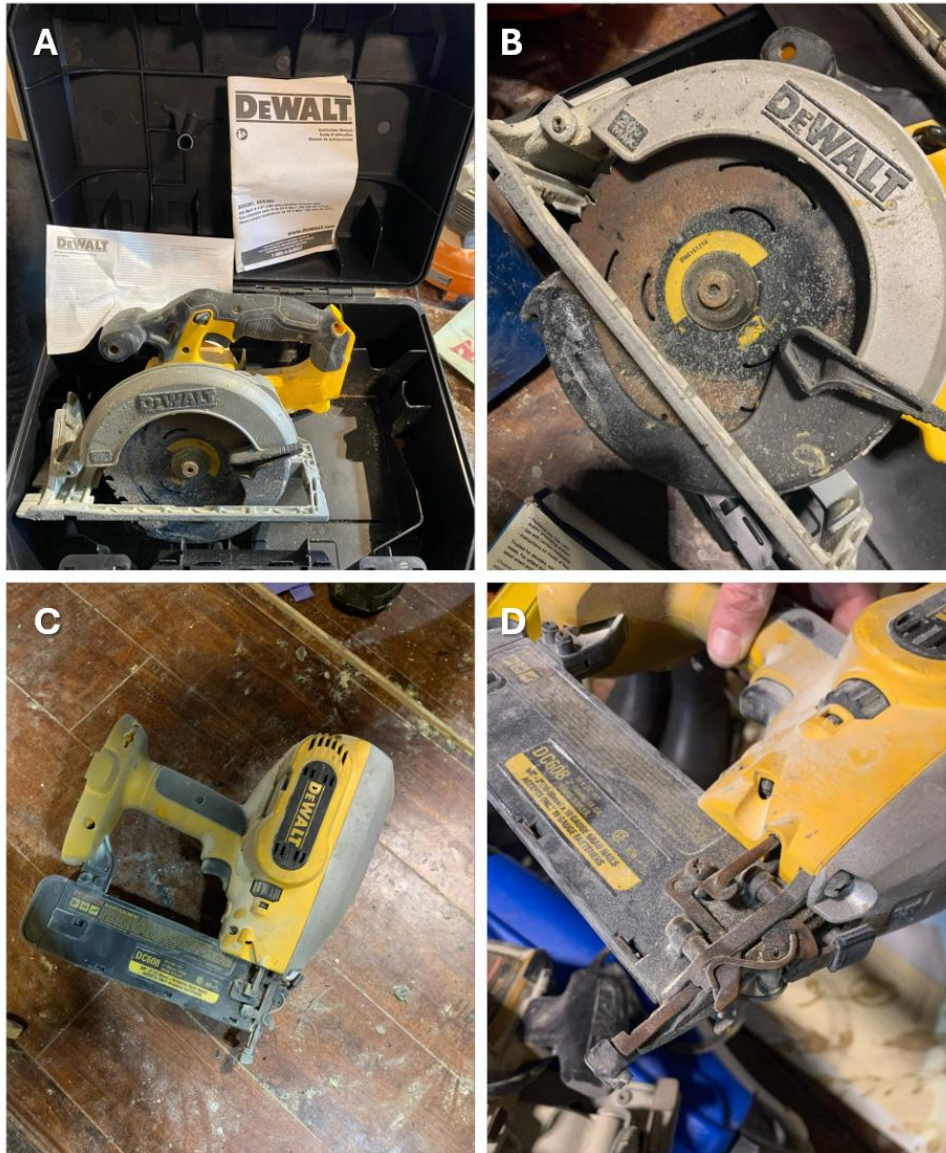
Figure 1: Corrosion of homeowners' tools. (A) DeWalt Circular Saw, one day after the fire event, no corrosion is evident. (B) DeWalt Circular Saw, one week after the fire event, new corrosion is evident. (C) DeWalt Brad Nailer, one day after the fire event, no corrosion is evident. (D) DeWalt Brad Nailer, one week after the fire event, new corrosion is evident.

In addition to the electrical system, we observed severe corrosion on many tools in the home's workshop, which was evident one week after the fire but not visible in photos taken the day after, as shown in Figure 1. Tools were stored previously in the house and had not developed corrosion, as shown in the before photos in Figure 1.

To address the corrosion issues within the laboratory and field environments. We have implemented the following procedures that have demonstrated significant reductions in degradation. (1) We treat all tools and instruments entering LiB post-fire environments as chemically compromised from first contact. Tools are not returned to service until chemical decontamination is complete. (2) We apply alkaline decontamination solution (sodium bicarbonate at a minimum 5% concentration or equivalent rated alkaline cleaner) to all metallic surfaces following LiB fire environment exposure. These are then rinsed with deionized water. Lastly, we verify pH neutrality at the surface before storage. (3) We have adopted the use of fluoride-resistant sample containers (HDPE or glass with PTFE-lined closures) for all sample collection and evidence storage from LiB fire scenes. (4) We recalibrate all measurement instruments against traceable standards after any LiB post-fire environment exposure before using results analytically or evidentially. (5) We document pre- and post-exposure tool condition with timestamped photography to establish equipment replacement records. (6) We have applied protective coatings rated for fluoride and chloride exposure to metal laboratory surfaces that have repeated contact with LiB fire investigation materials.

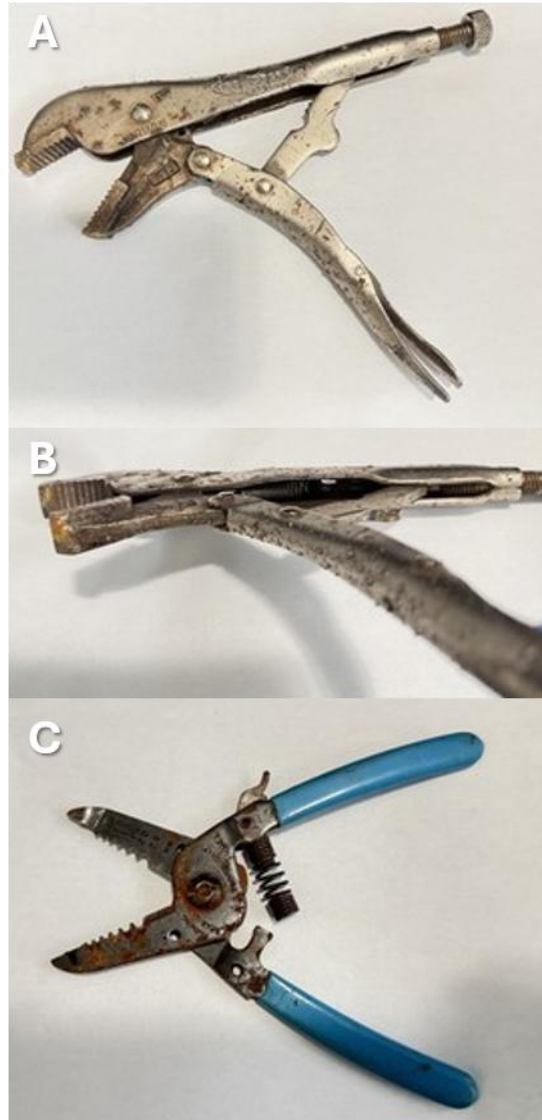
Figure 3: (A) Irwin Vise-Grip locking pliers, full body view. Scattered corrosion initiation sites are distributed uniformly across all exposed metal surfaces. The discrete, isolated oxidation pitting pattern, rather than continuous surface rust, is a diagnostic signature of halide-induced localized passive film breakdown. The pliers were in serviceable pre-exposure condition before entering LiB post-fire environments. (B) Same Vise-Grip, close-up detail of the jaw and body mechanism. The dense distribution of discrete pitting sites across the metal body is visible. Corrosion concentrated at machined surfaces and fastener contact points, consistent with galvanic acceleration of dissimilar metal interfaces. (C) Wire strippers with polymer-coated handles. Heavy rust formation on the pivot bolt, cutting blades, and return spring. Corrosion was confined to uncoated metal components; the polymer grip surfaces remained unaffected.
